IDR Sheet	1	of	2	Sheets	Final Record Book	Page			
Contract	C-7852			Day	Thursday		Date	July 22, 2010

## Inspector's Daily Report

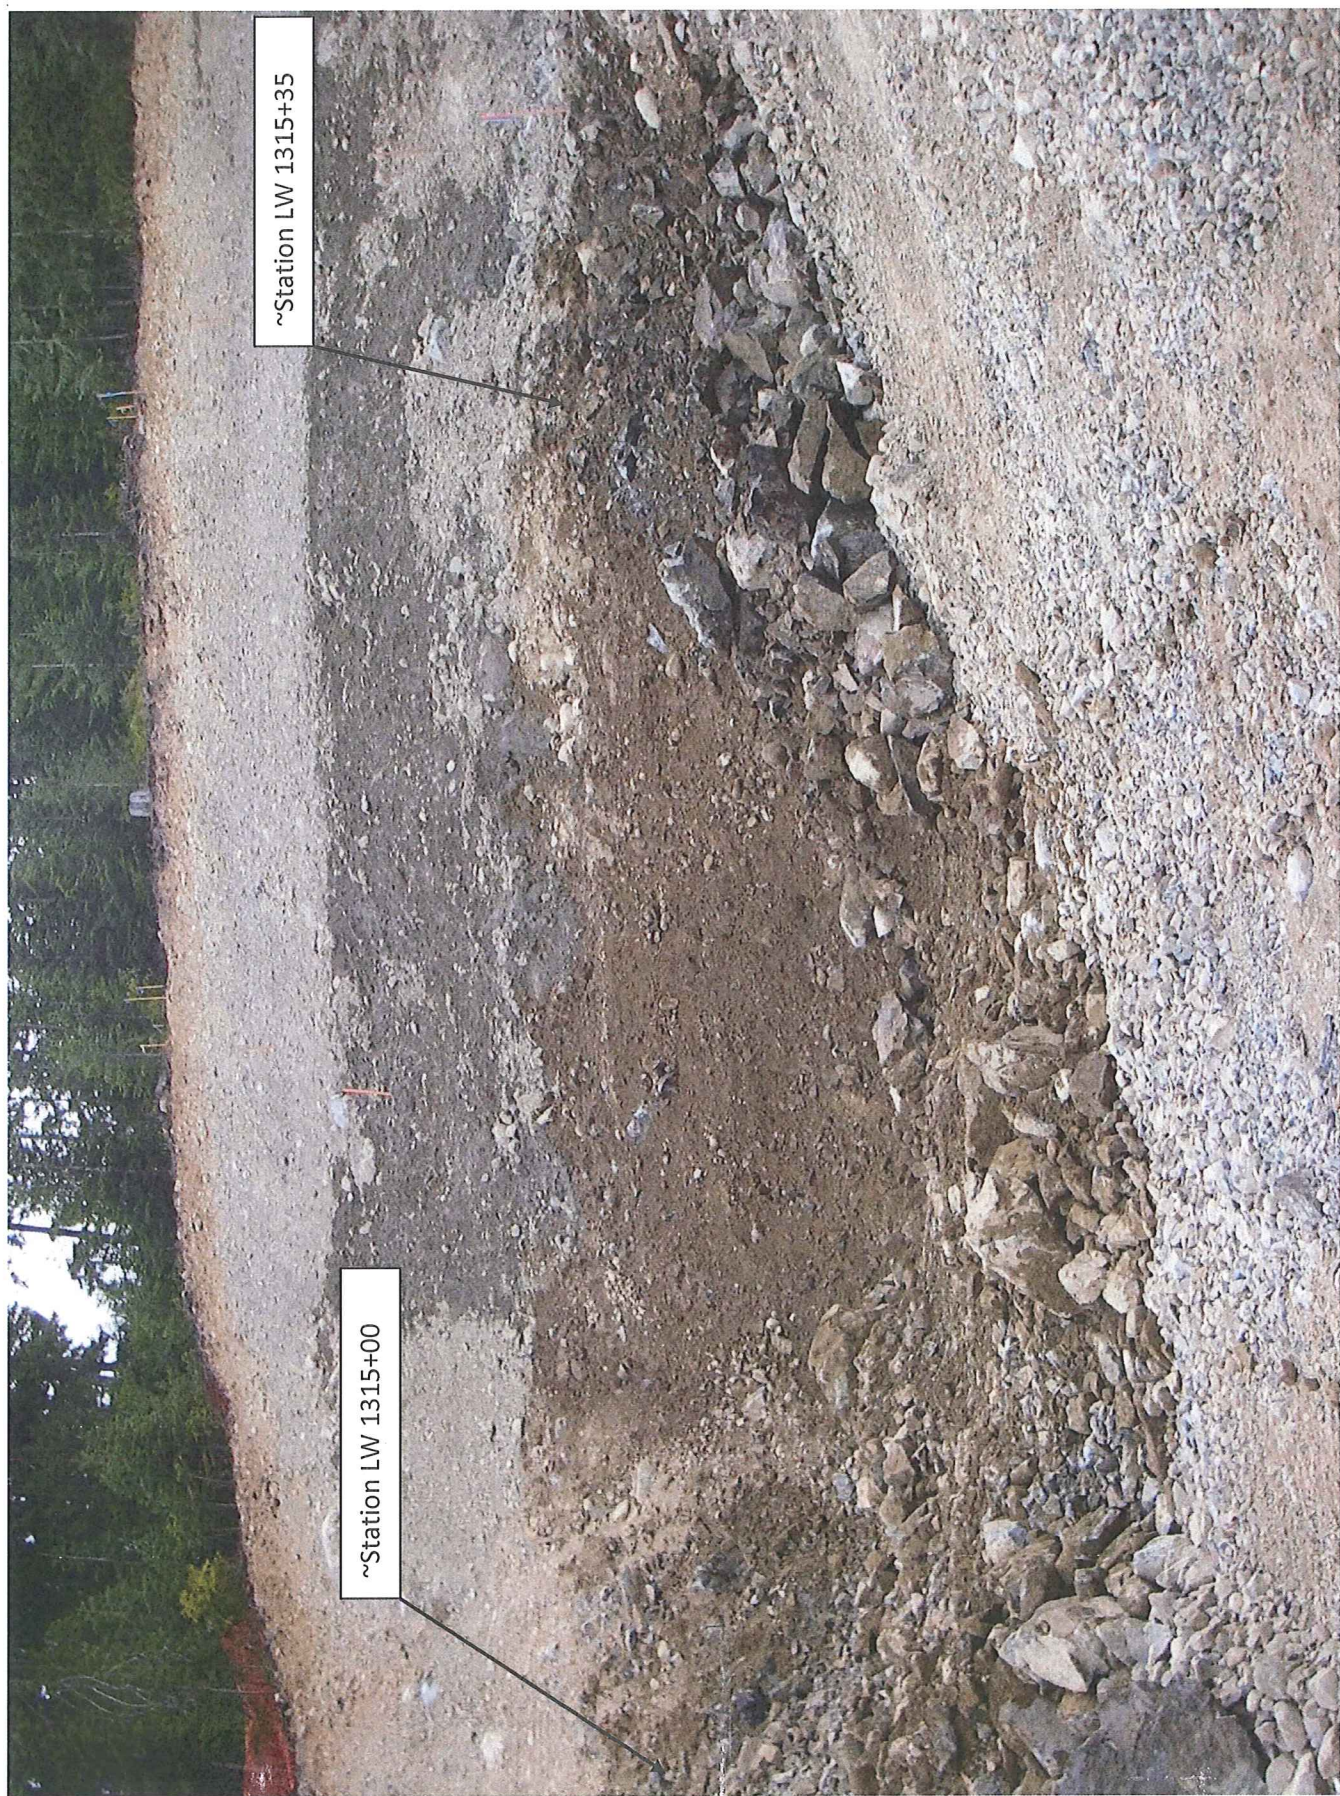
I arrived on-site around 9:30am and met Brad Schut at approximate station LW 1315+00. Brad and I had the contractor begin excavating at the pre-split location in an attempt to locate the bedrock limits. The contractor began excavating on the west end (LW 1315+00) and encountered highly fractured, weak bedrock at this location. I had him excavate toward the east where he encountered unconsolidated deposits consisting of silty sand with cobbles and boulders to approximate station LW 1315+35 where we again encountered highly fractured, weak (Figure 1). The bedrock was rippable at both locations. I performed additional field mapping to determine the limits of bedrock and unconsolidated deposits. Based on this additional field mapping it appears that more competent bedrock is encountered at approximate station LW 1315+75. I indicated to Brad that the Geotechnical Division would take this field information and produce a memorandum with alternative slope design recommendations for this location.

Figure 1. A photograph of the soil/rock section located from approximate station LW 1315+00 to 1315+40.

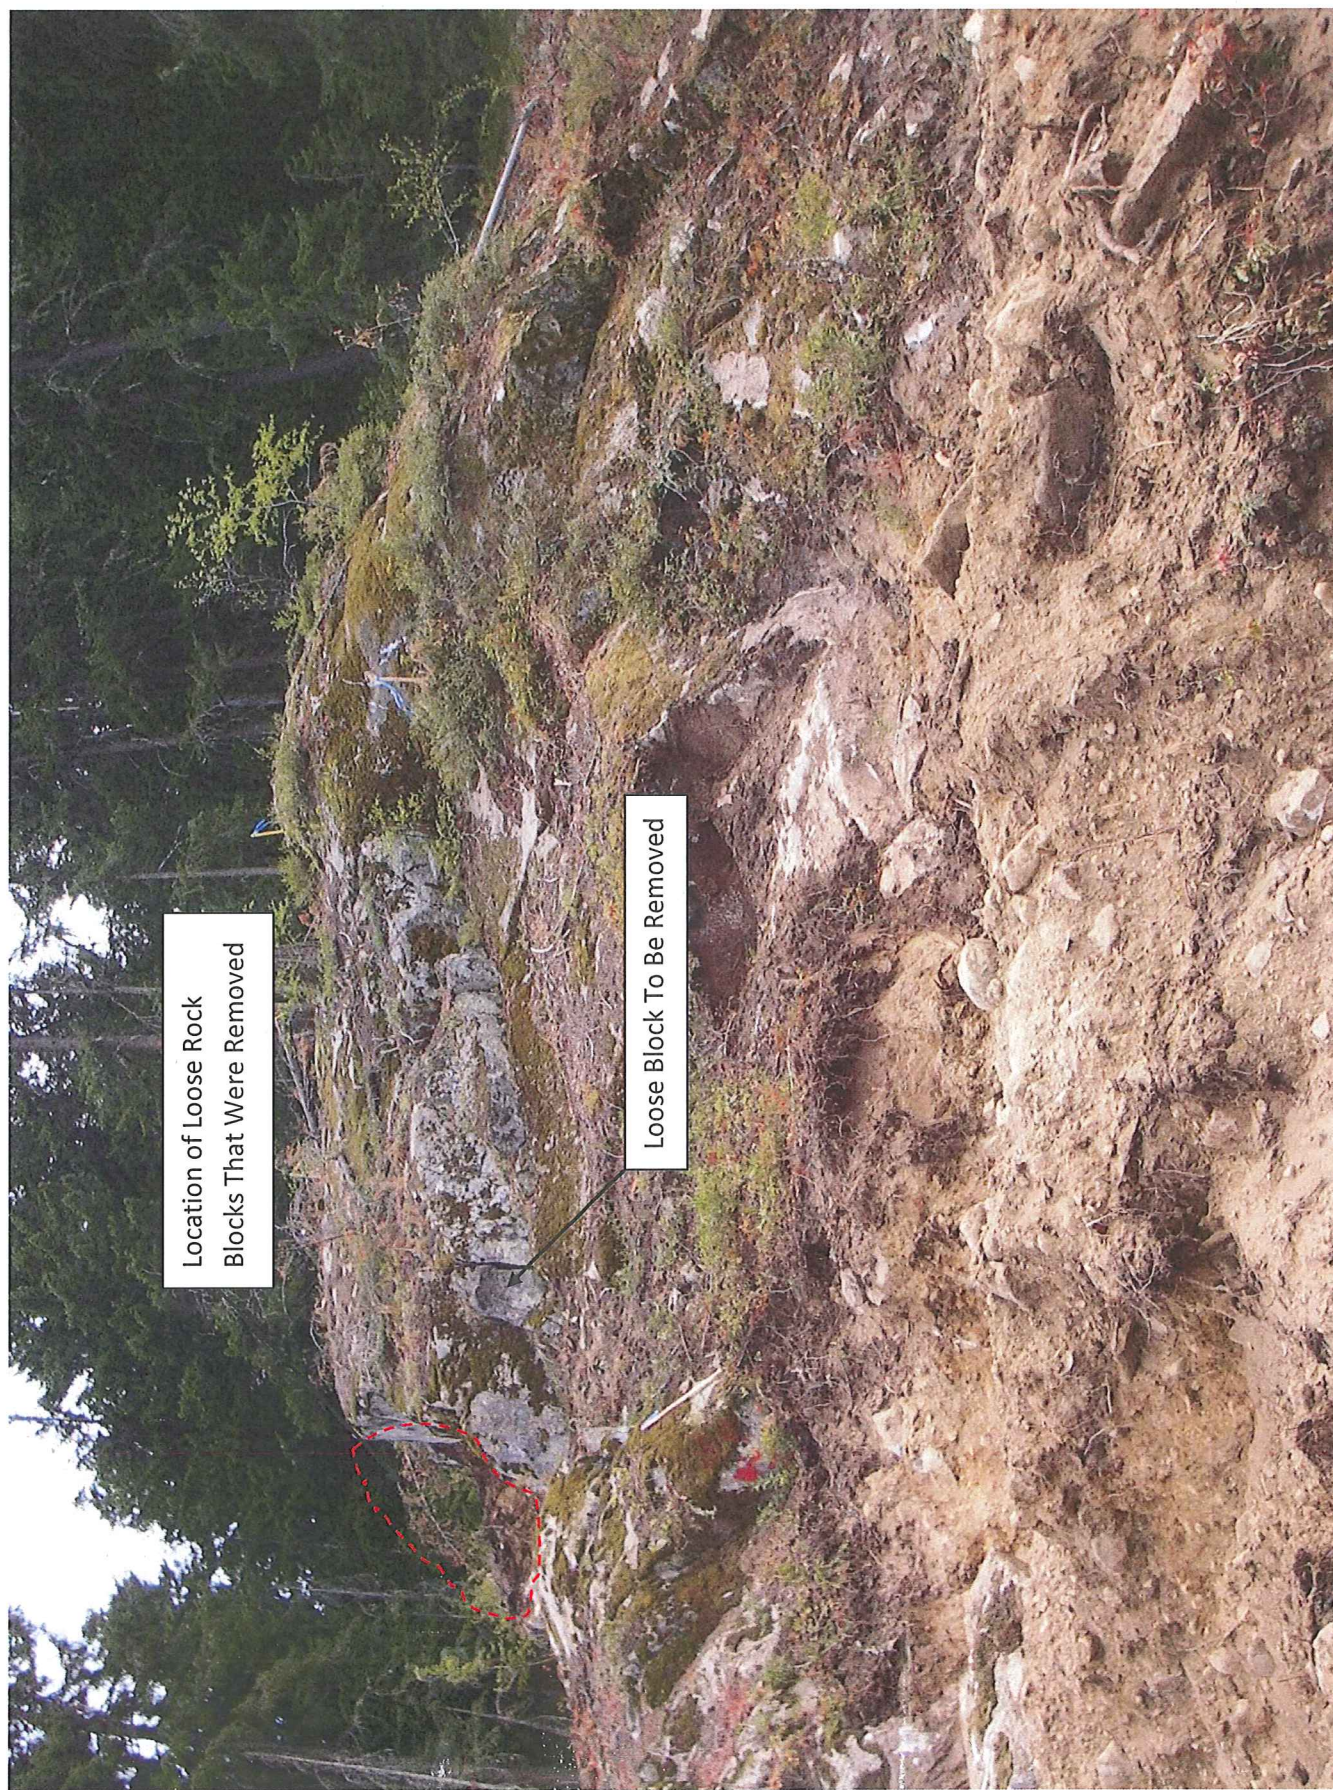
Brad and I then walked to the outcrop located upslope of the pre-split line at approximate station 1334+00. It appears that all of the loose blocks that were identified for scaling in our previous memorandum, dated 7/21/2010, had already been removed except for one rock block (Figure 2). Brad indicated that he would have the contractor remove that rock block before they begin drilling for the pre-split line.

Figure 2. A photograph of the upslope outcrop located at approximate station LW 1334+00.

Brad and I drove to the Hyak office for a 12:00 pm meeting to discuss the work to be performed for the outcrop located immediately above the pre-split line at approximate station LW 1334+00. Kuney indicated that they would perform the work when they build the cat road to drill the pre-split line and they requested that WSDOT pay for the additional fill material and equipment to reach the recommended type L bolts located on the outcrop. I indicated that the bolts were not time sensitive and could be installed during the installation of the cable net anchors and Hi-Tech (sub contractor for the cable nets) could perform the work. Kuney agreed and indicated they would contact Hi-Tech and request an estimate for the additional work.

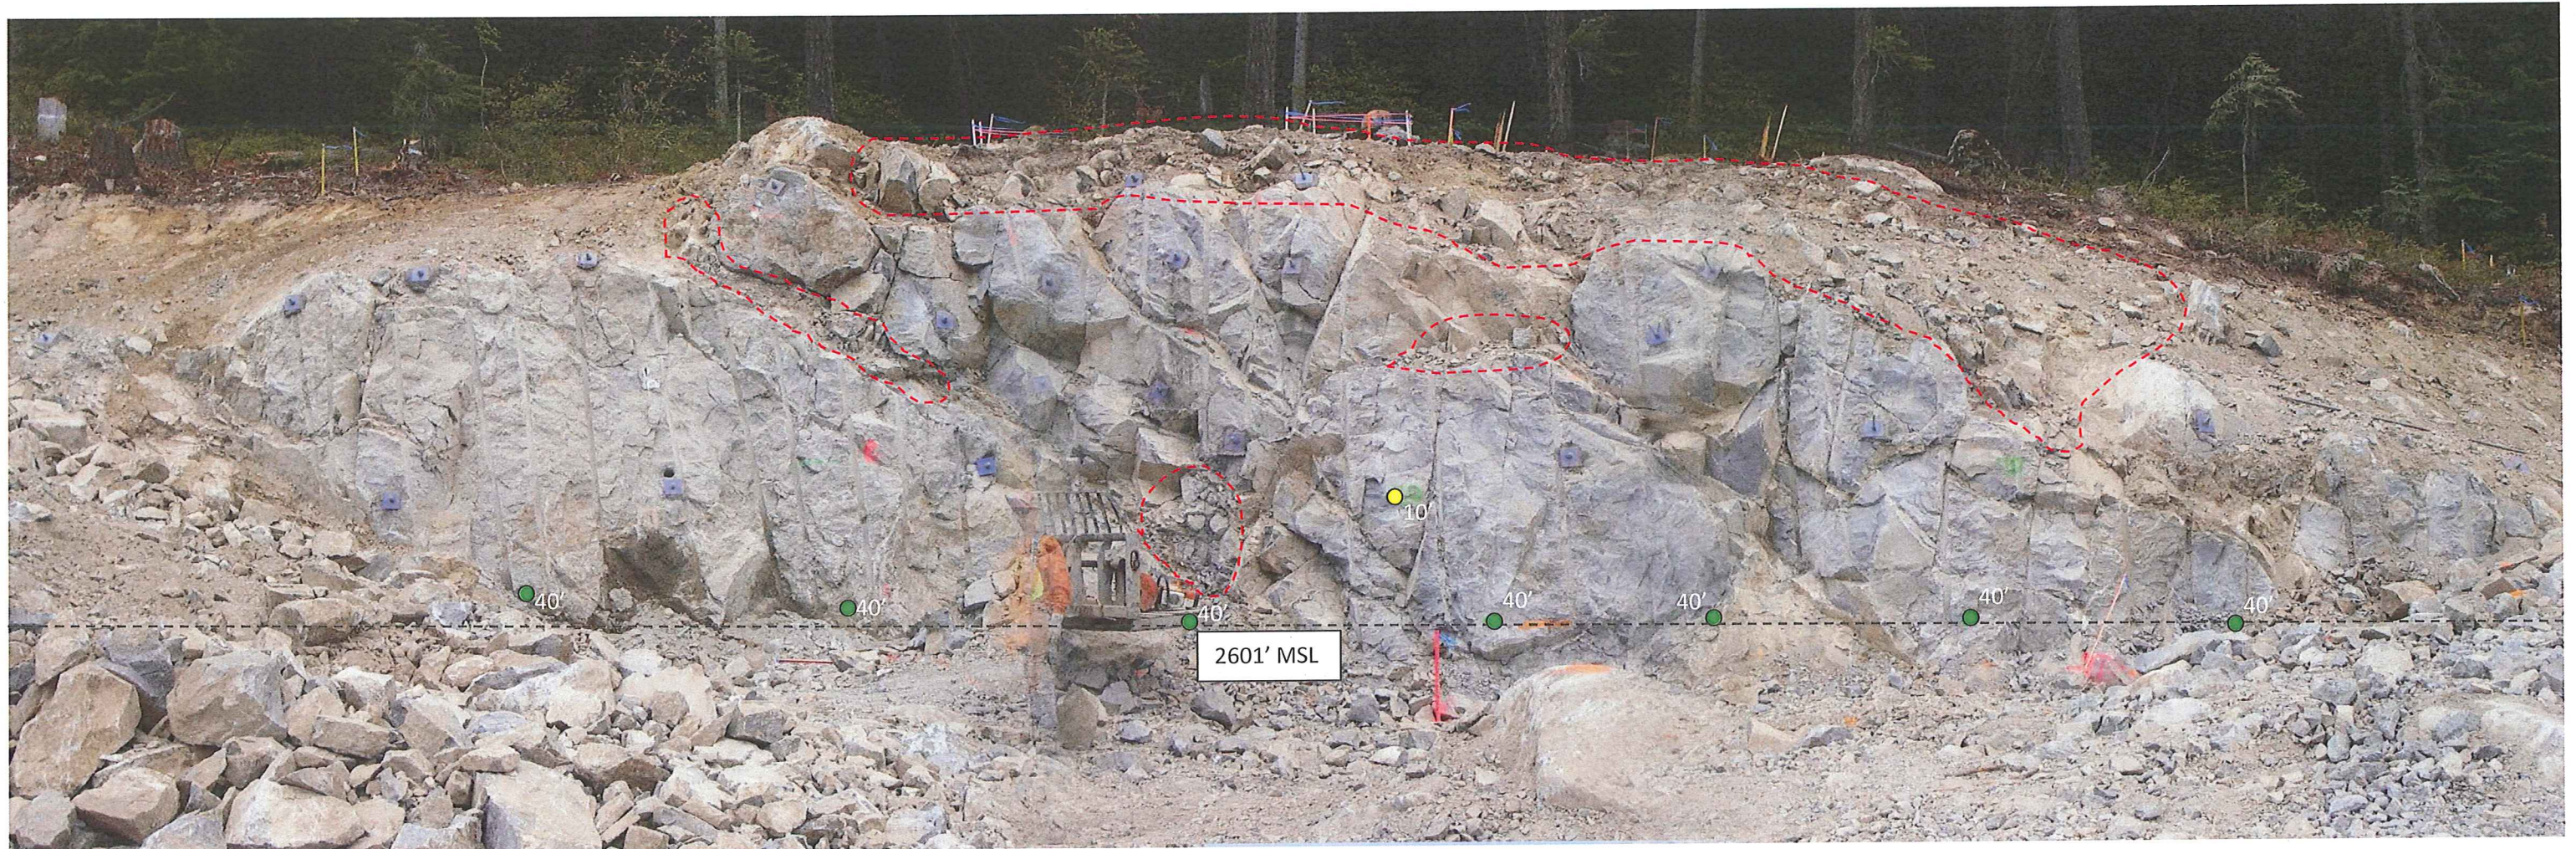
Brad and I walked to the rock cut at approximate station LW 1337+00 to inspect the recently excavated lower portion of Lift 1. This was not a full 12 foot high lift since we are at the top of the cut. The proposed row of pattern dowels will only be located between 6 and 8 feet below the previous row of pattern dowels. Telephone conversation with Steve Lowell and Norm Norrish indicated that we should locate the next row of pattern dowels at this current location and lengthen them to 40 feet in an attempt to stabilize potentially adverse shallow dipping through-going geologic structure that is exposed at the highway cut and is through-going throughout the remaining portion of this cut section. Brad and I located the row of pattern dowels and one spot dowel from approximate station LW 1336+50 to 1337+25 at an approximate elevation of 2601 MSL (Figure 3). Two rock knobs remain at the bottom of the lift that did not get blasted and removed. Brad indicated that they would remove the knobs during the next blast. We located a type L dowel in this knob and it will be installed following the mucking of the next lift. Not much of the scaling and dressing recommended for Lift 1 had been performed and is shown in Figure 3.

Figure 3. A photograph of Lift 2 from approximate station LW 1336+50 to 1337+00 to 2601 MSL.

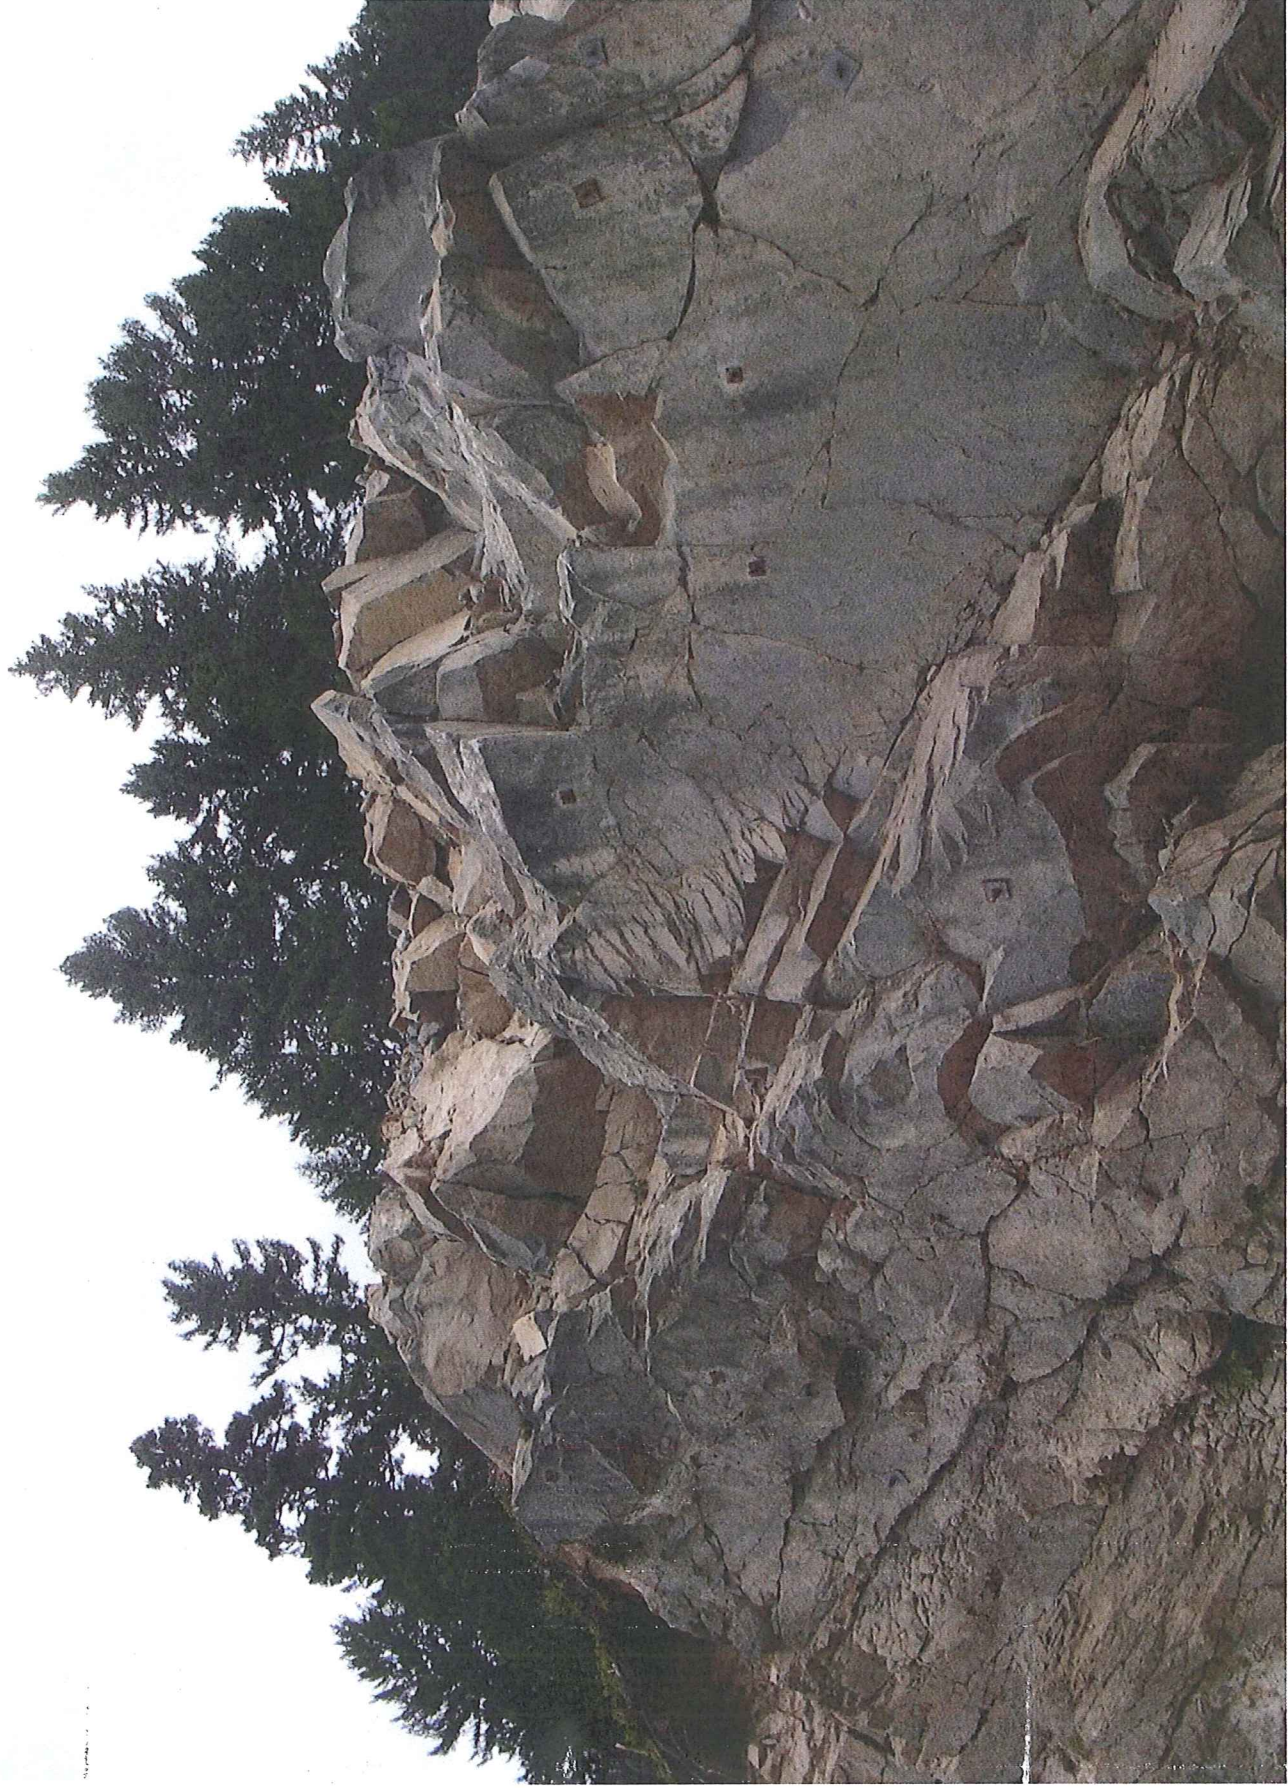
Following the meeting, Brad wanted to look at some loose rock located on the crest of the highway cut at the station LW 1337+00. It appeared that there was quite a bit of loose material located on the crest (Figure 4). Brad proposed removing this material during closures of the highway during blasting operations. I indicated that the loose blocks located on the crest of the slope could be removed by the contractor during highway closures if it was accomplished in a safe manner.

Figure 4. A photograph of the highway cut located at approximate station LW 1337+00. Note all the loose rocks located at the crest of the slope.
